### Case History

# Identification of a unique vibration problem

by Jim McDowell

and Peyton Swan, P.E.

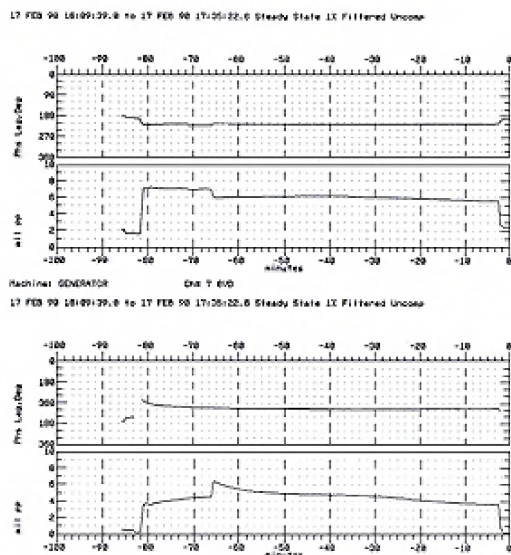
Figure 2

Data showing increasing step change in vibration amplitude at bearing #5 and #6.

The first tapes that arrived at Bently Nevada on 18 February 1990 showed a rather severe 6 mils (152  $\mu$ m) pp increasing step change in the vibration amplitude on the vertical transducers at bearings #5 and #6 as shown in Figure 2. The horizontal transducer at bearing #5 indicated a somewhat lower 3.5 mils (89  $\mu$ m) pp change, while the horizontal readings at bearing #6 were still lower at 2 mils (51  $\mu$ m) pp. Bearings #3 and #4 had not exceeded 2 mils pp (51  $\mu$ m) in amplitude change.

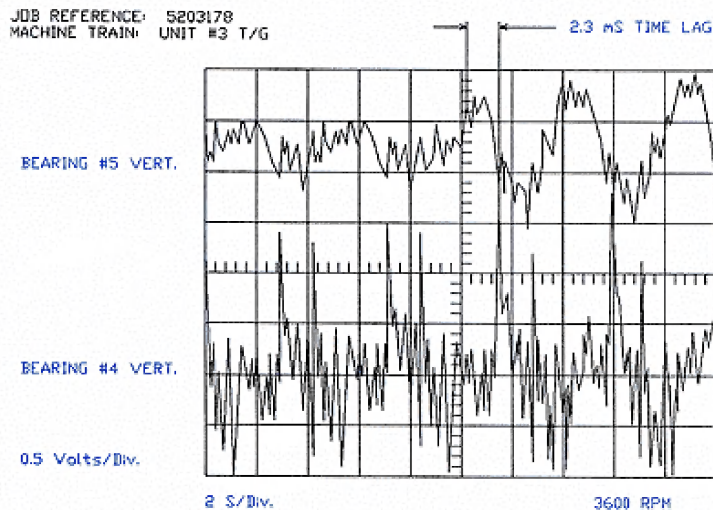
Figure 4, the direct timebase trace of bearings #4 and #5 vertical transducers during a vibration step change, shows a 1-3 millisecond lead in the signal change at bearing #5, indicating the source of the problem to be in the generator as ►

Figure 4  
Direct timebase of bearings #4 and #5 vertical transducers.

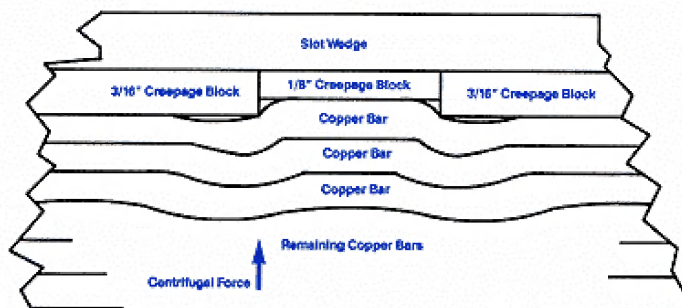
Figure 5  
(Exaggerated) example of copper bar deformation due to centrifugal force and non-uniform blocking.

In September 1990, the plant took the unit off line for an inspection and overhaul. The generator rotor was returned to the repair shop that did the original rewinding and carefully disassembled. As suspected, it was found that the G-11 type insulation (creepage blocking) beneath the slot wedges had been improperly sized. Varying sizes of blocking had been installed during reinstallation of the slot wedges.

Figure 5 illustrates, in an exaggerated form, how the copper bars deformed because of centrifugal force and non-uniform blocking, preventing them from expanding axially. The final repair resolution involved slightly milling the underside of the slot wedges in order to use a uniform strip of creepage block. This created a smooth slip plane between the copper and the blocking insulation, allowing uniform axial expansion of the copper bars.
